Rail Accident Investigation Branch

# Rail Accident Report

**Electrical arcing and fire under a train near  
Windsor & Eton Riverside  
30 January 2015**

Report 18/2015  
October 2015

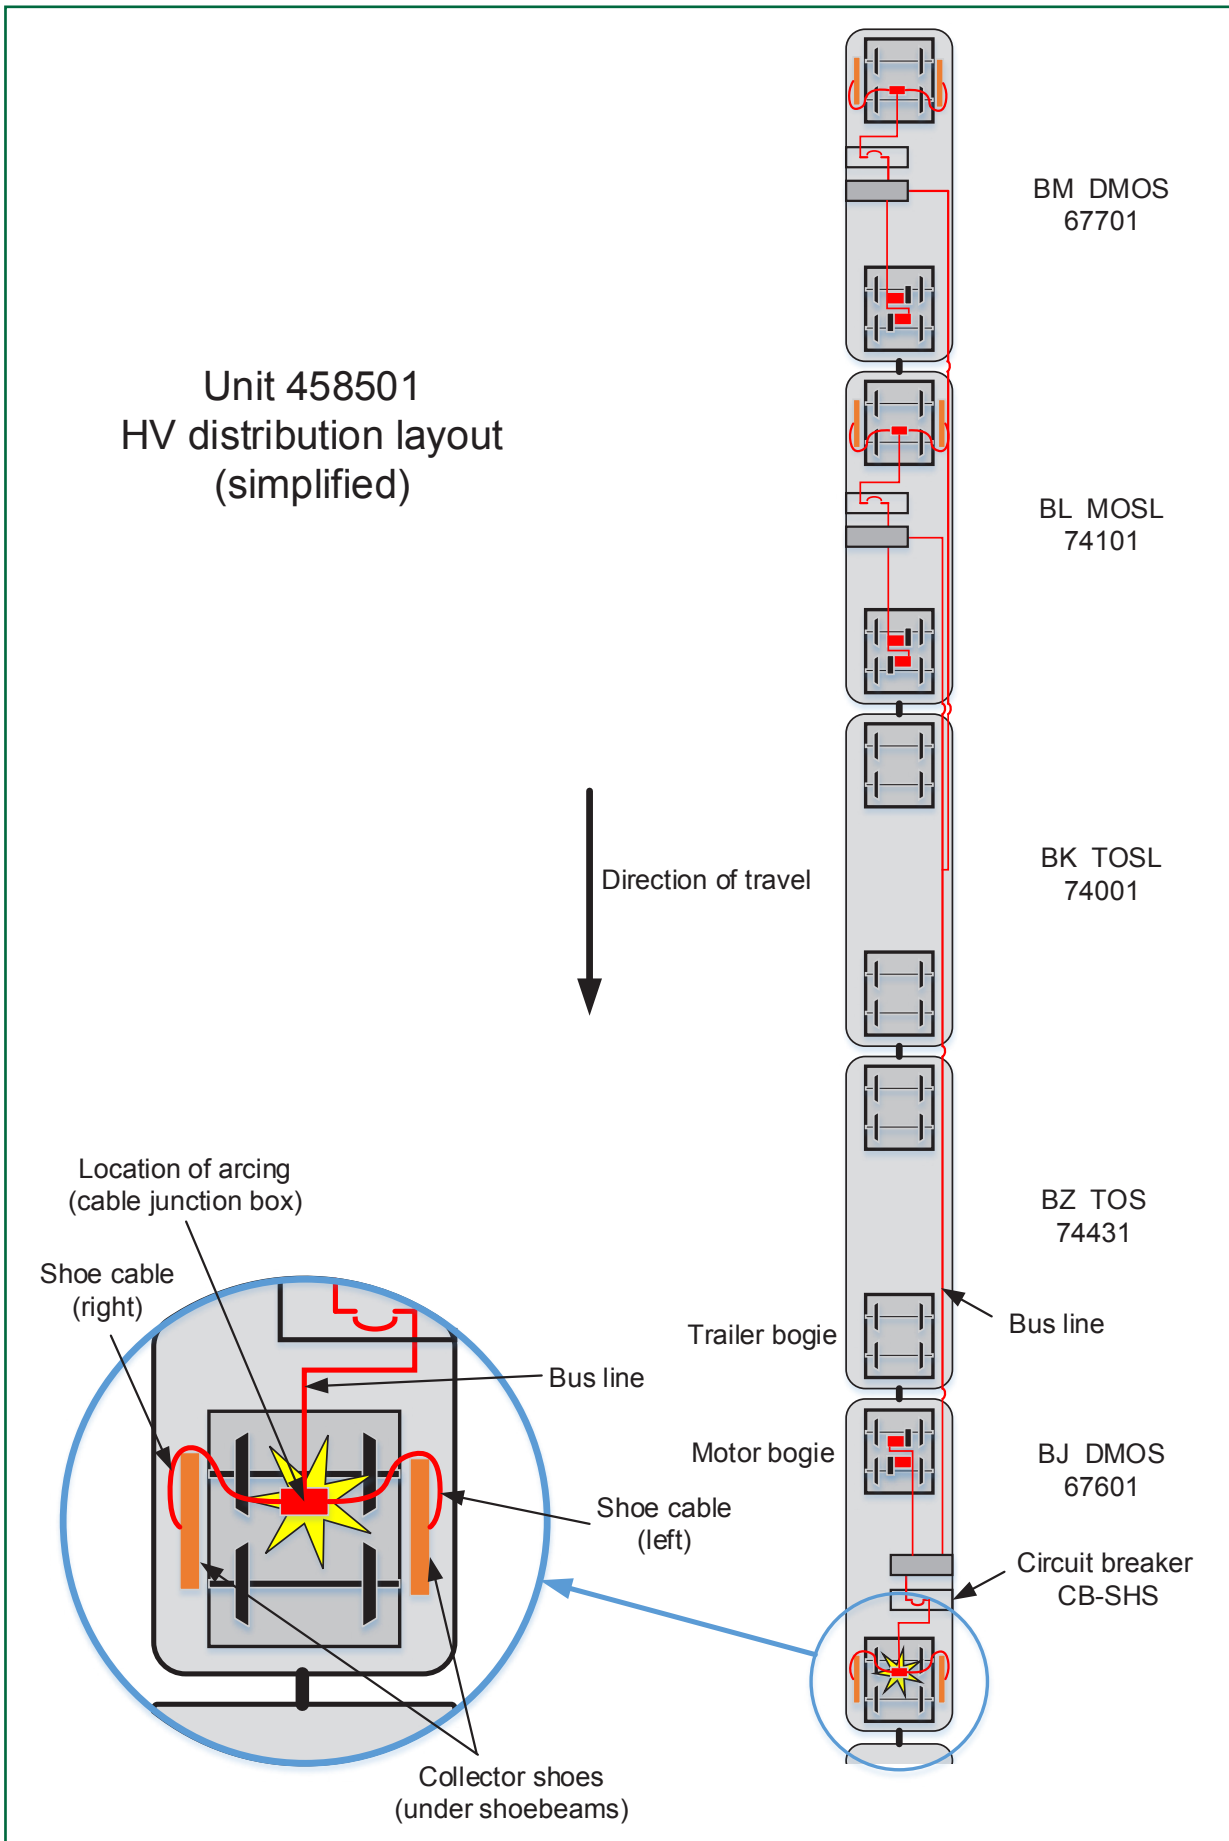
Figure 11: diagram of high-voltage distribution layout on class 458/5

- 93 On the class 458/5 train, there are three high speed circuit breakers (HSCB), one associated with each set of collector shoes, and referred to by Alstom as 'circuit breaker – shoe gear high speed' (CB-SHS) (figure 11). These are mounted on the underside of the vehicle, and there is no protection for faults which may occur in the cable between the collector shoes and the CB-SHS. The maximum rated service current for a class 458/5 unit is 1930 amps.

- 95 In the TMS of unit 458501, all three CB-SHS are recorded as having operated at the same time (to within one second) when the train was travelling at about 14 mph (23 km/h). There is no record in the TMS of any of the push buttons having been operated. The Bus Line Earth Leakage Relay circuit does not monitor the cable on the shoe gear side of the CB-SHS and could not have detected the arcing, and the CB-SHS is rated to trip on overcurrent (instantaneous trip setting of 3600 Amps). This leads to the conclusion that the CB-SHS tripped on overcurrent when it detected high current flowing from the traction supply to the vehicle body.
